POK PHON: FROM A FISHING VESSEL TO A TOURIST BOAT IN THREE MONTHS

Anne Klaasen
ratopreis@hotmail.com

This photo essay deals with the transformation of the Pok Phon, a thirty seven year old Thai fishing vessel. Every two to three years, boats like the Pok Phon have to be repaired, a process which involves cleaning, replacing damaged wood, recaulking, painting, and overhauling the engine. In 2001 the Pok Phon, rather than undergoing just the usual repairs, was completely restored and transformed into a tourist boat. The shipyard where this operation took place is situated in the south of Thailand in the village of Kantang. I visited the shipyard between August and November 2001 in order to do a boat building internship.

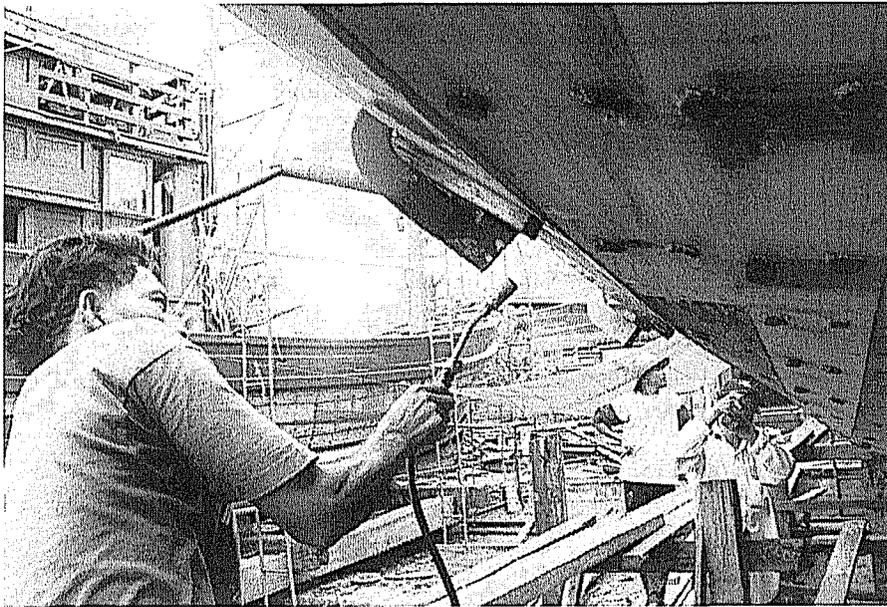
When I arrived at the shipyard the boat had already been stripped down to its frame. Only the pieces of the hull that recently had been replaced were left. The rebuilding of the frame was not done with the help of blueprints, but on the basis of the workers' long experience in boat building. The foreman who co-ordinated the project took all the construction decisions.

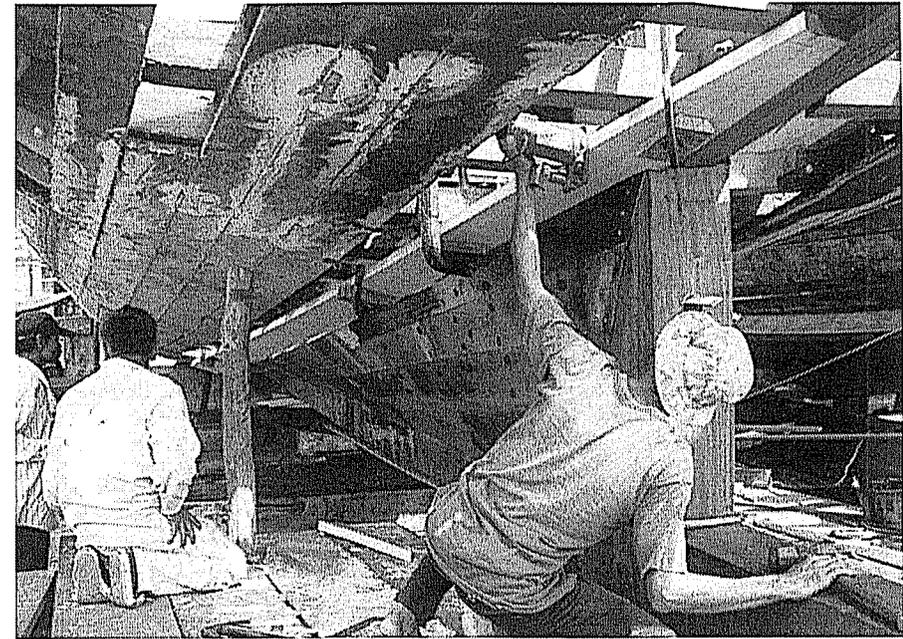
In order to give the boat a new hull, 12-metre planks were clamped to the frame. In order to bend these planks into proper position, the workers used oil and a blowtorch. The oil was put on the plank and then it was heated with the blowtorch. When the oil started to boil and the plank became dark brown in colour, that was the sign that it could be bent it into position with the help of clamps.

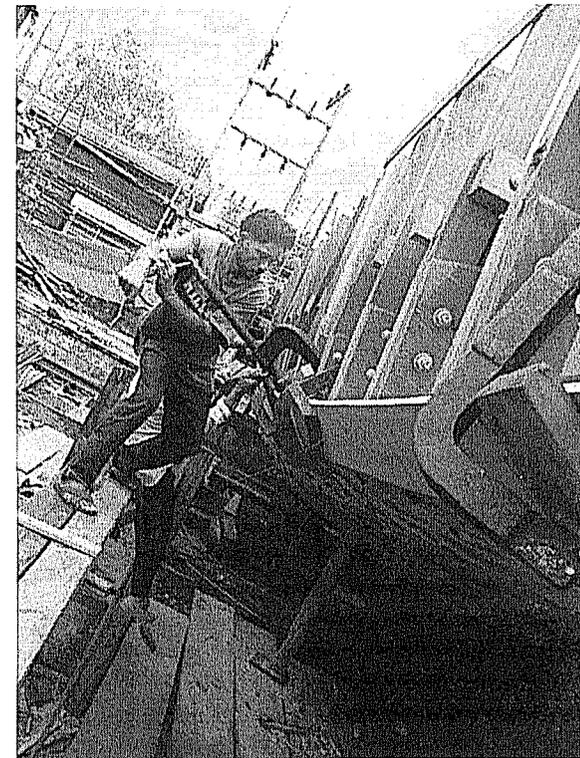
Sometimes a jack was used in order to put planks in their proper position. If a plank did not fit perfectly, the boat builders simply trimmed it to fit.

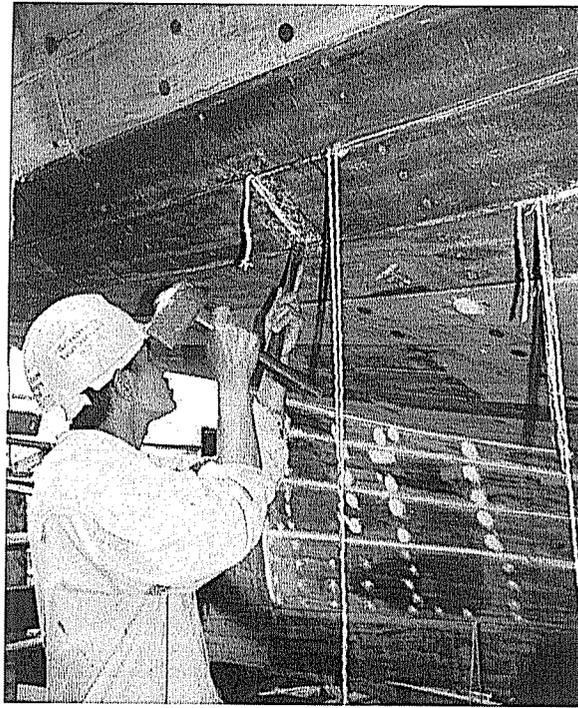
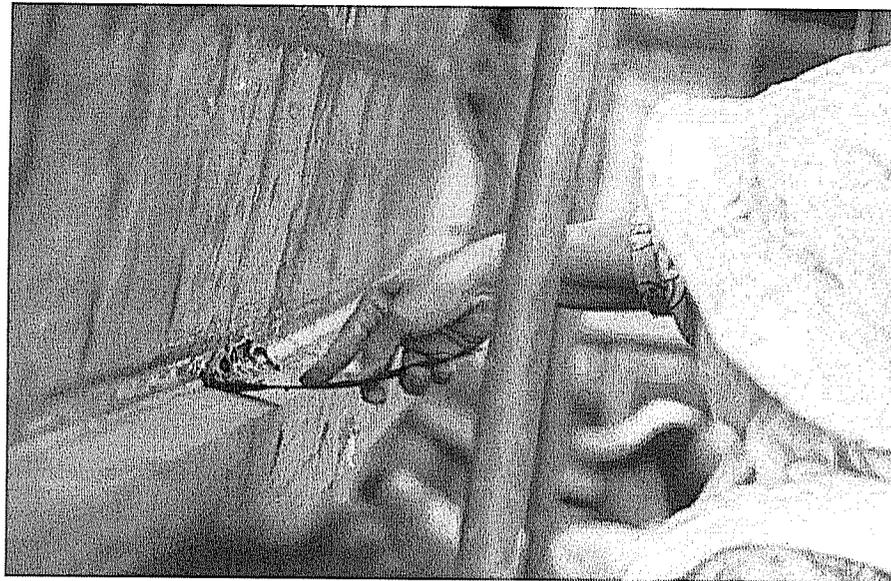
Planks were forced to bend to the shape of the frame using clamps. The clamps were left in place until a plank had been fixed with wooden pins. After holes were drilled through the planks and the frame, palm wood pins were hammered into these holes. On the other side the pins were trimmed, notched, and split with a wedge. Finally, the part of the pin that was still sticking out was removed and sanded. No bolts or nails were used to attach the planks to the frame.

After the hull was finished the caulking began. First the spaces between the planks were deepened with a special chisel. Then cotton threads and flax were put into these spaces. The flax was treated with an orange powder (probably red lead powder) to lubricate it so that it would go more easily into the clefts and in order to prevent the flax from rotting.

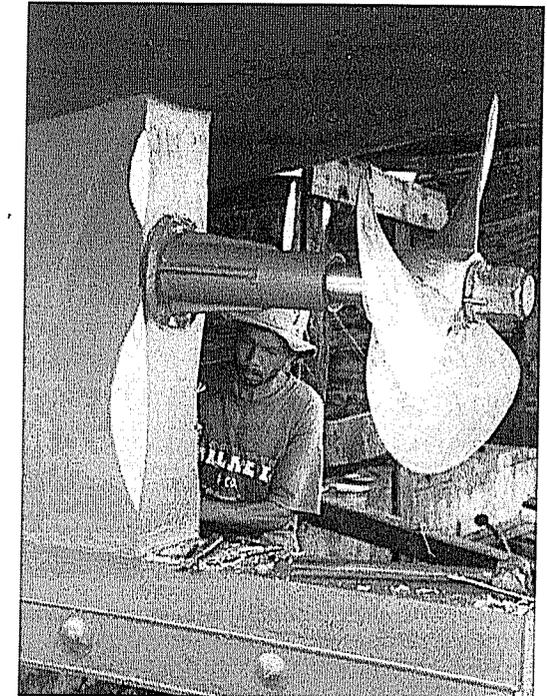
The new deck was not constructed in a traditional way and with traditional material, but with plywood, glass fibre mats, and polyester to make it more durable.

The foreman is shaping the beam behind the propeller so that water will flow towards it more easily.

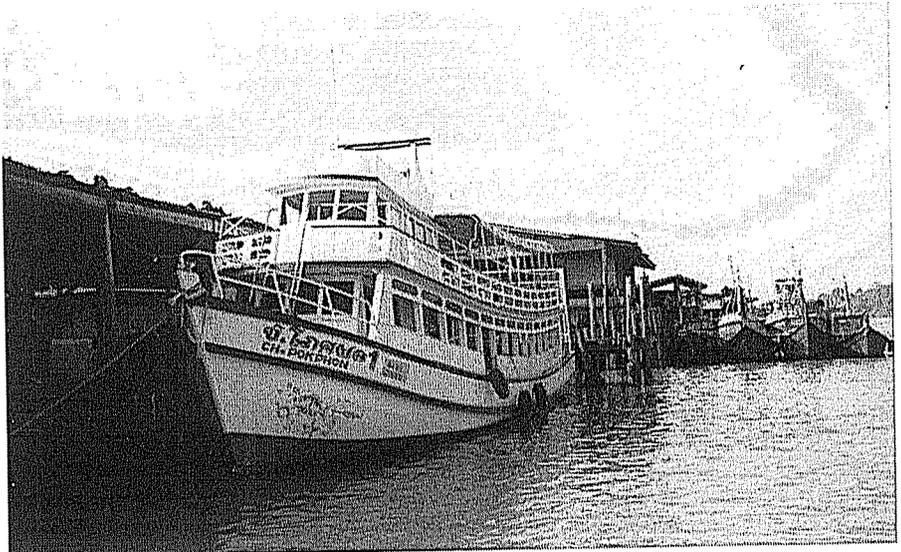
Before the boat was launched a special ritual was performed. Cakes, fruits, a cooked chicken, a roasted pig, incense, candles, and Buddhist ritual sheets of paper were placed on the front deck. The bow was decorated with red and white strings over a red cloth. Underneath these strings were some fresh picked orchids and a colourful plastic flower bouquet hung from the bow. The shipyard boss performed the ritual. After he had washed the bow and had sprinkled some fragrant oil and talc powder on it and the front deck, he started praying for good luck. Finally he used firecrackers to drive away bad ghosts. After the ritual, the food was given to the workers and then the boat was launched.
