POK PHON: FROM A FISHING VESSEL TO A TOURIST BOAT IN THREE MONTHS

Anne Klaasen
ratopreis@hotmail.com

This photo essay deals with the transformation of the Pok Phon, a thirty seven year old Thai fishing vessel. Every two to three years, boats like the Pok Phon have to be repaired, a process which involves cleaning, replacing damaged wood, recaulking, painting, and overhauling the engine. In 2001 the Pok Phon, rather than undergoing just the usual repairs, was completely restored and transformed into a tourist boat. The shipyard where this operation took place is situated in the south of Thailand in the village of Kantang. I visited the shipyard between August and November 2001 in order to do a boat building internship.

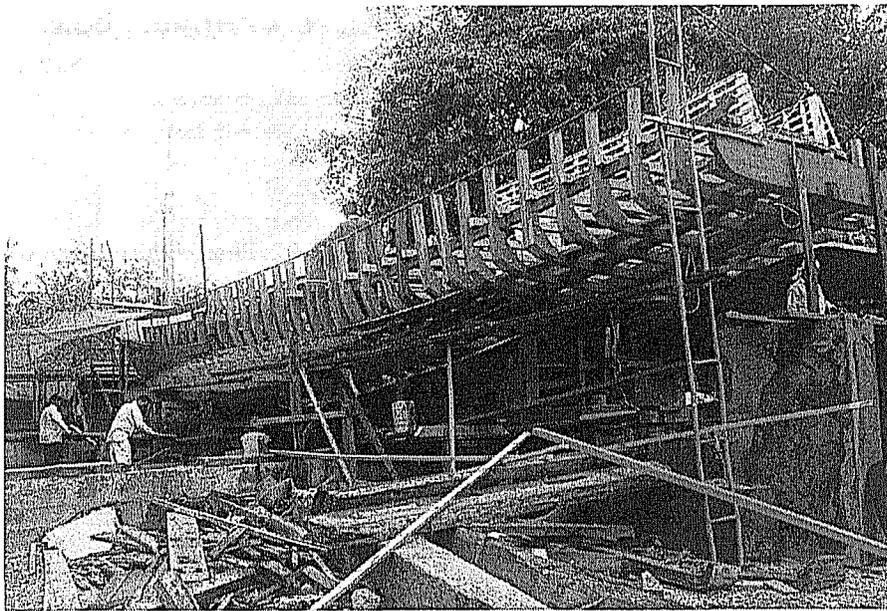
When I arrived at the shipyard the boat had already been stripped down to its frame. Only the pieces of the hull that recently had been replaced were left. The rebuilding of the frame was not done with the help of blueprints, but on the basis of the workers' long experience in boat building. The foreman who co-ordinated the project took all the construction decisions.
